Marchington

Conservation Area Appraisal

July 2015

Document: 5895 Marchington Conservation

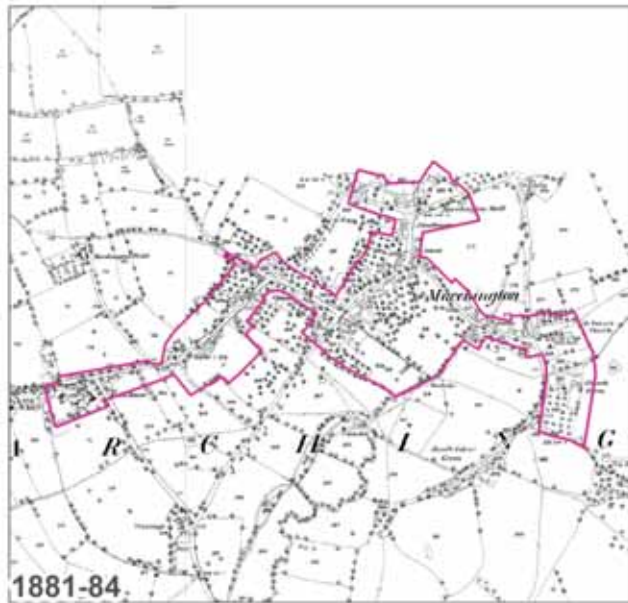
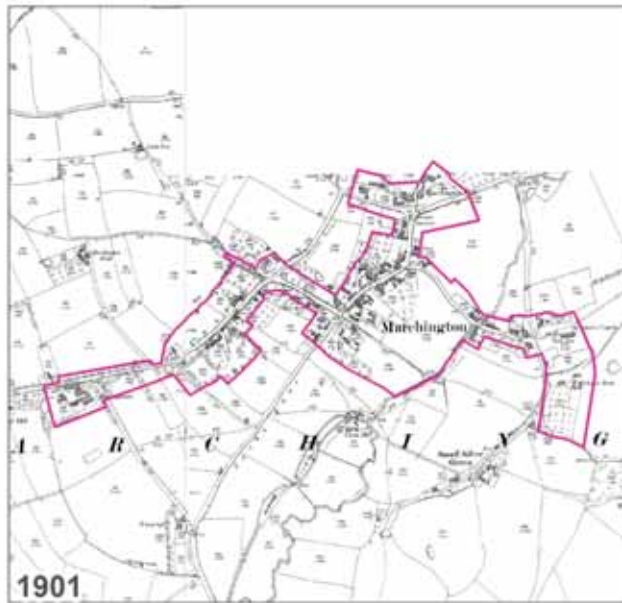
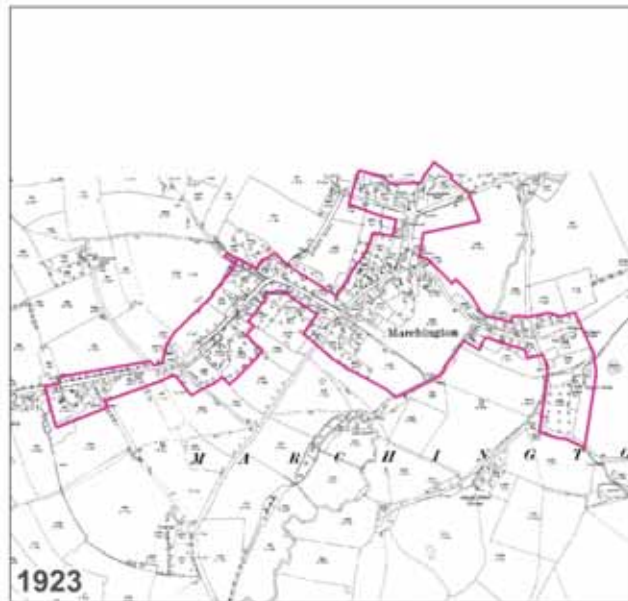
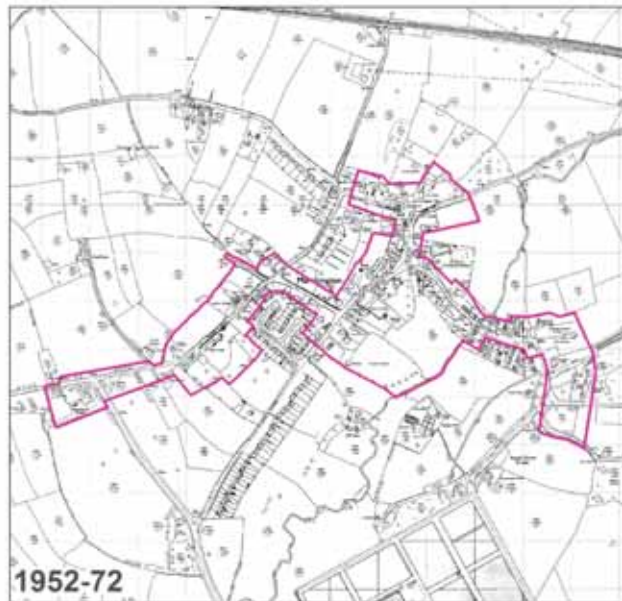
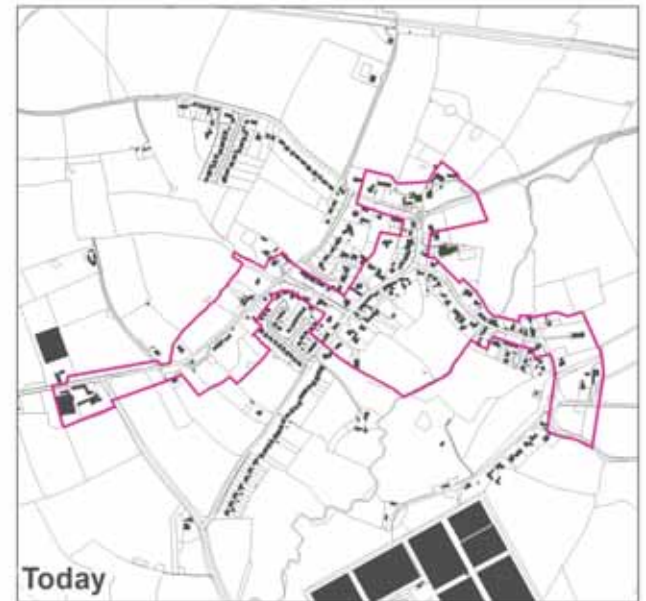
Figures 3 - 7: Historical Development in Marchington from 1881 - present

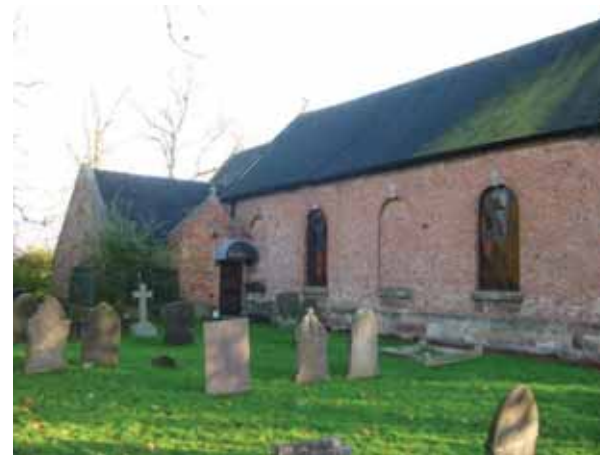
- 6.5 The Church of St. Peter is a small brick structure, built in 1744 to a late Baroque style; the most distinctive feature is the West Tower which is topped with an octagonal cupola. It is a Grade II* listed structure, and further Grade II listed Memorials sit within the Churchyard to the north and south of the building. An attractive view within the village is that of the tower, and west rusticated doorway, framed by the mature avenue of Lime trees that bound the pathway through the Churchyard.

St Peter's Church, Church Lane

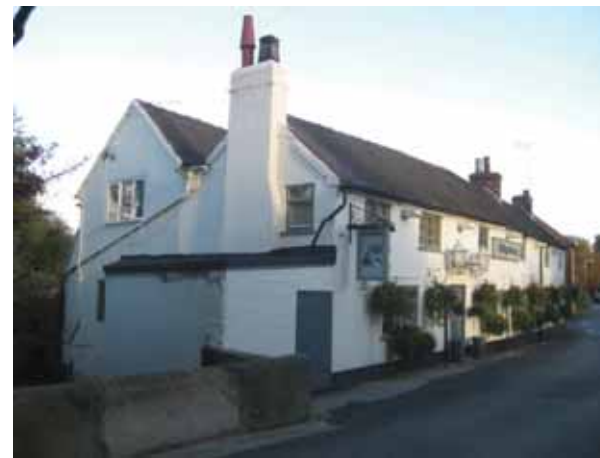
6.8 Between the pub and the next row of cottages that includes Brookside House, lies a Brook that runs to the River Dove to the North. This is an interesting feature within the townscape, with a parapet of sandstone slabs.

Dog & Partridge, alongside the sandstone parapet of the Brook bridge

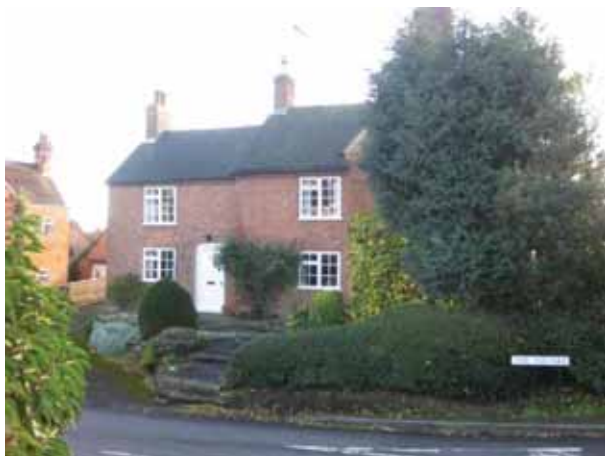
6.11 Around the junction with The Square there is a cluster of attractive detached dwellings, predominantly early 20th century. Bramley Cottage on the junction is an older building dating in the latter decades of the 1800's. The windows here are notably smaller, and the building floorplate is L-shaped and incorporates the orientation of a gable to the street as seen on other properties. Adjacent are the double fronted pair of detached Victorian dwellings, Willingham House and Netherleigh; the red orange

Bramley Cottage, Church Lane

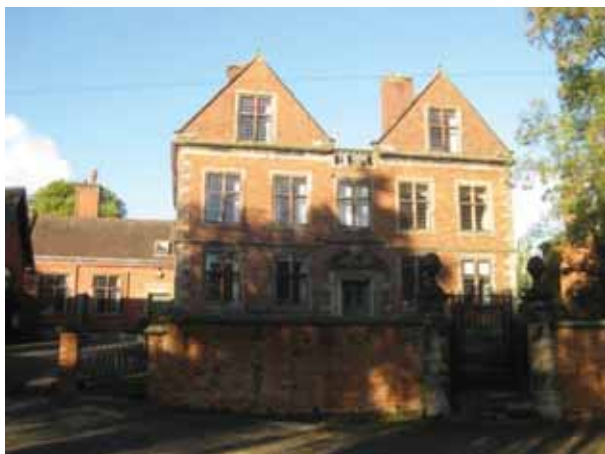
Marchington House, The Square

- 6.14 The rising topography towards Marchington Hall forms an important set piece at the northern end of The Square, fronting onto a mature tree set within a small green; Green Lane runs to the east and Hall Road to the west. Marchington Hall is Grade II* listed and dates from c.1690 with later

additions. It is built in red brick (flemish bond) with ashlar quoins and dressings, plain tile roof with coped vergers. The distinct gabled front elevation is used here and perhaps will have informed this character feature that is apparent across the village. A high red brick wall with stone copings bounds the property.

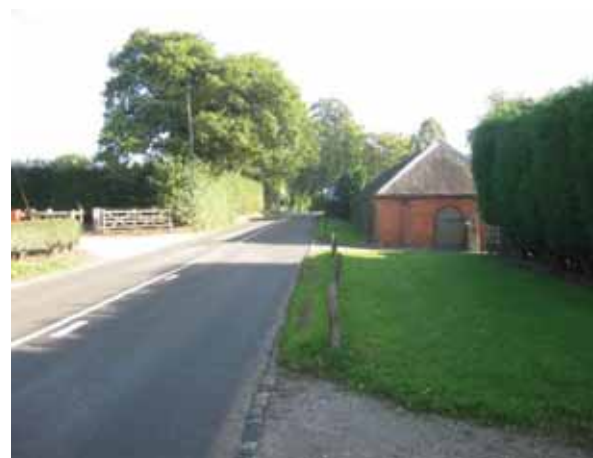
Bag Lane, facing east, Field House Stables on the right

- 6.18 Approaching the conservation area from the west along Bag Lane, the entrance is marked by Field House. A Grade II listed dwelling dating from the late 18th Century. The building is screened from the street by the single storey stable block that extends along the street frontage. The road from here gradually descends between steep hedges towards St Anne's Cottage which terminates the vista. St Anne's Cottage is a distinctive building within the village. Formerly two cottages, this dates from 17th Century and is timber framed with a plain tile roof.

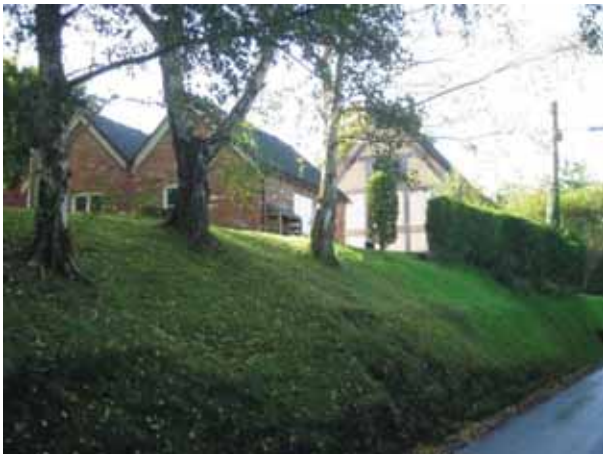
Sunken banks of Bag Lane, facing east towards St Anne's Cottage

- 6.19 A small former Methodist Chapel is set back from the street here, built in 1840, it closed for services in 1970. The building is orientated on a east west axis, fronting Bag Lane with a gable.
- 6.20 The road continues east, narrowing through a tunnel of trees and steep high banks where a number of cottages sit above the lanes, one such complex is the attractive Laundry Cottage and High Bank.

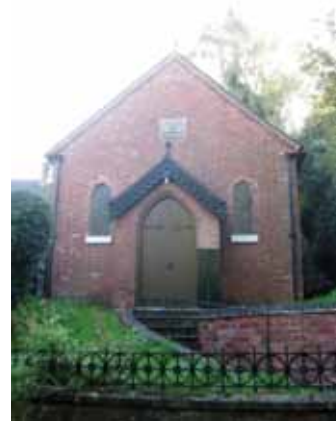
The Methodist Chapel, Bag Lane

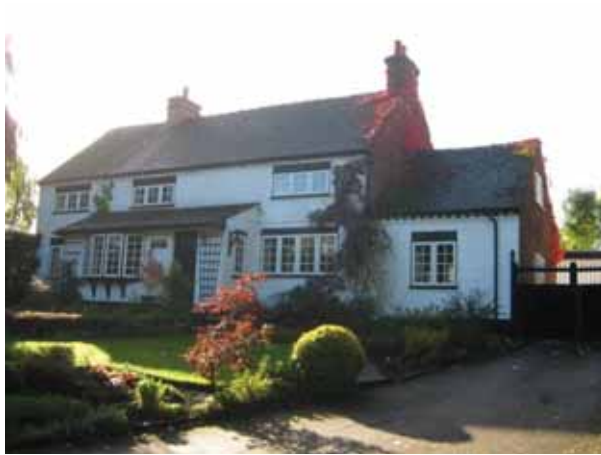
Marchington Villa, Bag Lane

- 6.23 Along the remainder of Bag lane the high hedges and sunken lane encloses much of the lane. Dwellings fronting the southern edge of the lane date from the late 1800's and post WWII period. Marchington Villa is an attractive contributor to the character in this lane, a painted brick two storey dwelling.

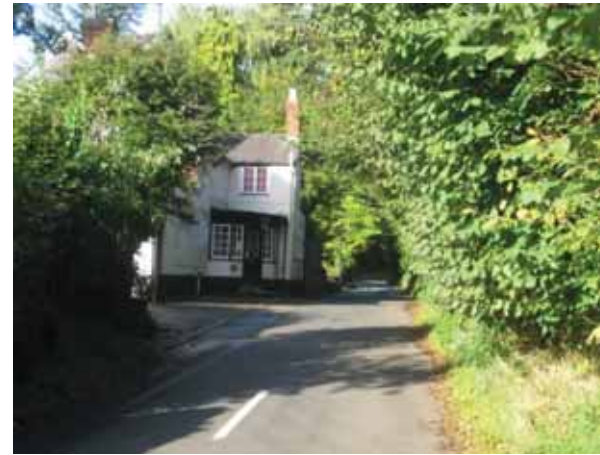
The Bulls Head, facing north west along Bag Lane

- 6.24 The Bulls Head public house is another notable feature along this section of Bag Lane. This is also a painted brick structure, but sitting back of pavement with a projecting gable, narrowing the road significantly.
- 6.25 The junction with High Street & Jack Street is marked by two noteworthy buildings within the village. Yew Tree Farm house sits to the north of the junction, James House to the south, both are Grade II listed.

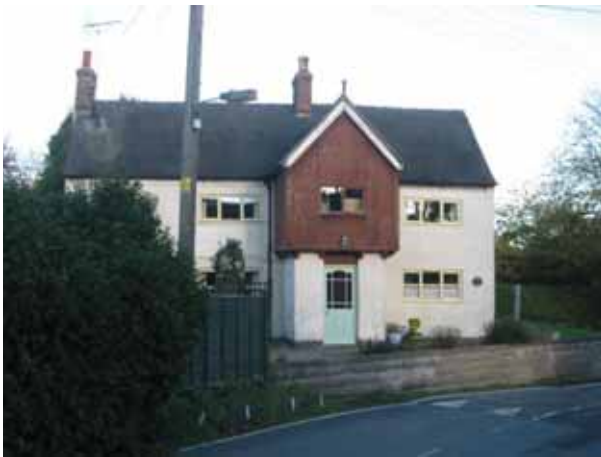
6.31 The conservation area generally benefits from good quality of built fabric. Yew Tree Cottage presents a unsympathetically altered building which has a strong relationship with the street.

- Yew Tree cottage, Church Lane

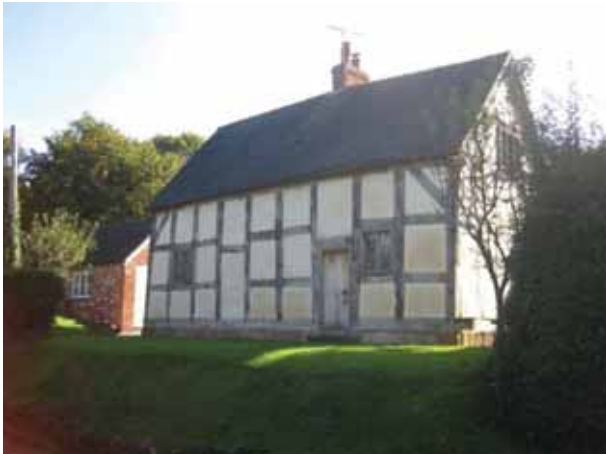
- ST. ANNE'S COTTAGE, BAG LANE (GRADE II)
Cottage formerly a pair. Timber framed dating from C17

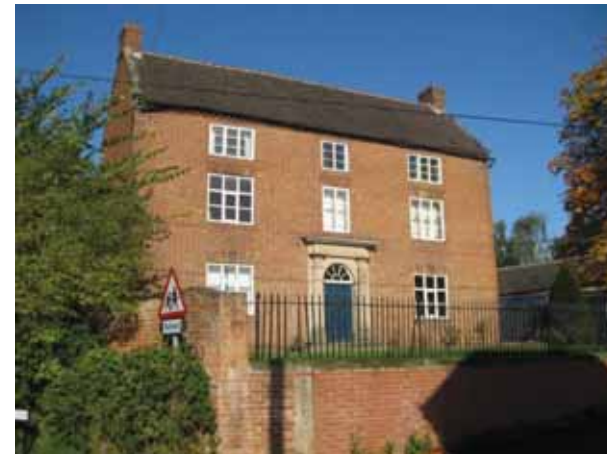
- YEW TREE FARMHOUSE WITH GATE, RAILINGS AND WALLS TO FORECOURT, HIGH STREET (GRADE II)
Red brick Farmhouse, gate, railings and walls dating from mid C18. Wrought iron gate and railings

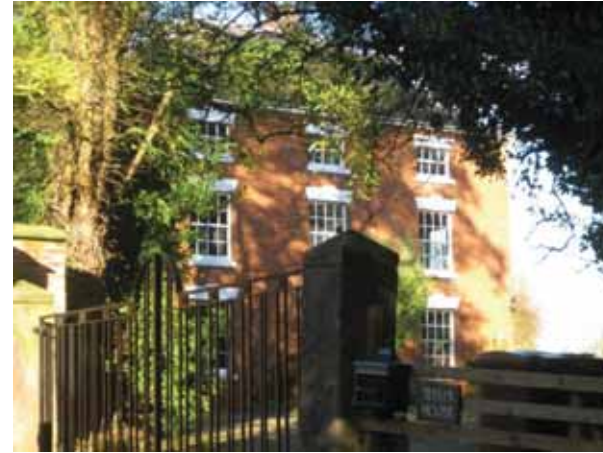
- TETLEY HOUSE (GRADE II)
Red brick dwelling, early C19 rebuilding of a C17 house.

- 6.15 To the east of the Hall is Tetley House, a rebuilt 17th Century home (as of the early 19th Century). It is a three storey height with reduced proportions to the second floor. There is also a central door with rectangular overlight, cornice hood and moulded surround. This is set back and occupies a less prominent position than its neighbour.
- 6.16 Green Lane to the east is a single track lane, sunken within high hedges and vegetation forming a tunnel like entrance to the village. The landscape opens out to the east over fields and the varied topography is visible.

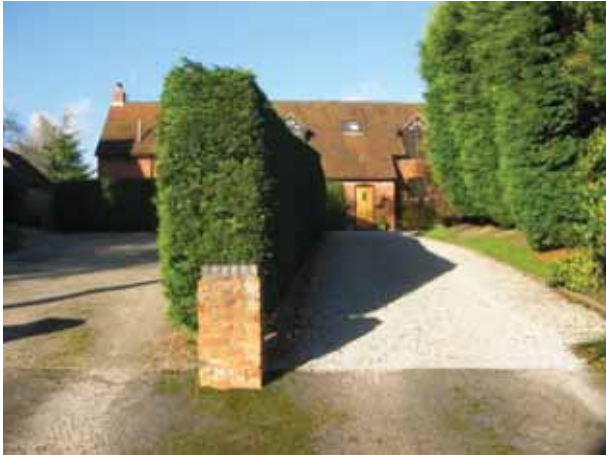
- STABLES APPROXIMATELY 15 YARDS NORTH EAST OF HALL CROFT FARMHOUSE (GRADE II)

C18 Red brick stables north-east of Hall Croft Farmhouse.

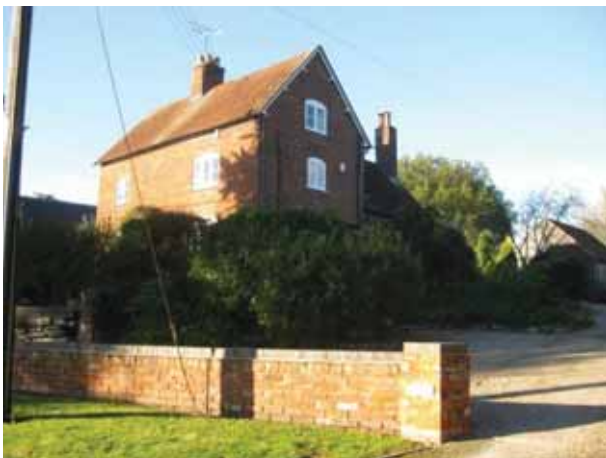
- HALL CROFT FARMHOUSE (GRADE II)

Brown brick farmhouse, dating from mid-C18.

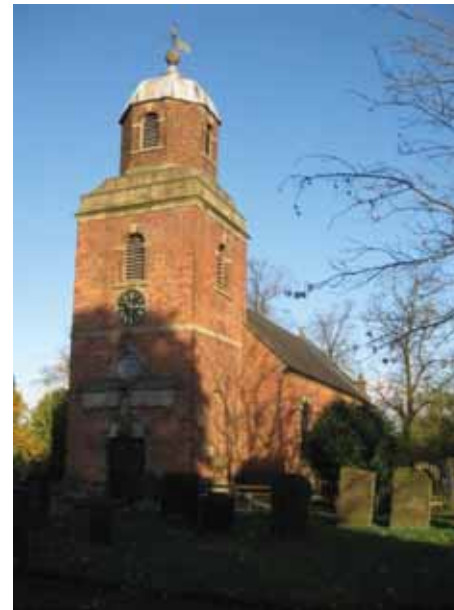
- CHURCH OF ST. PETER, CHURCH LANE (GRADE II*)

Red brick construction, by Richard Trubshaw, dating to 1742; chancel rebuilt late C19.

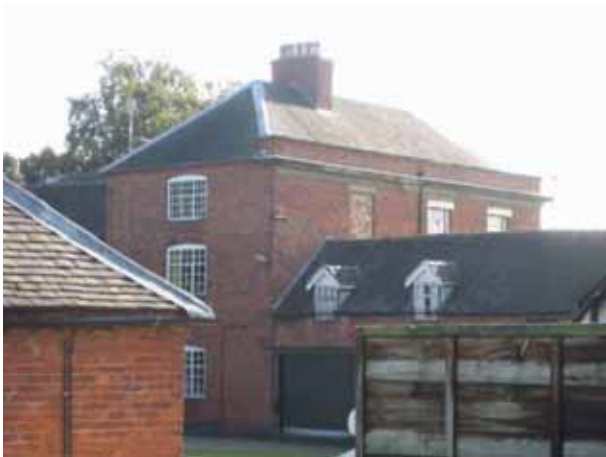
- FIELD HOUSE (GRADE II)
Red brick construction dating from late C18 with later alterations and additions.

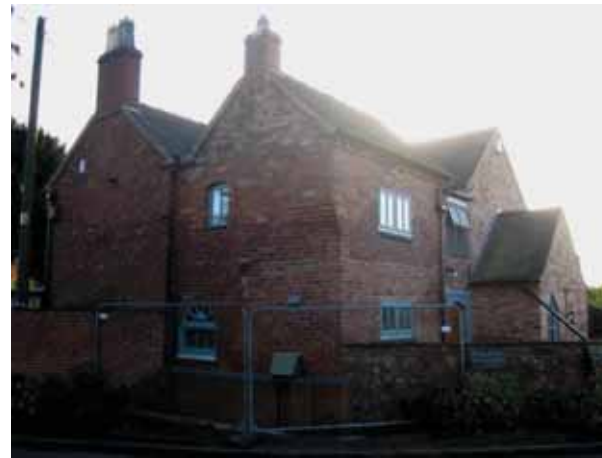
- Church House, Church Lane
This presents a particularly prominent corner feature on Church Lane, with a distinctive radial corbel . The gable frontage creates an interesting set piece with The Cottage, on arrival to the village, framing the view on turning west along Church Lane. The orientation of the gable to the street is a character that is seen around the village.

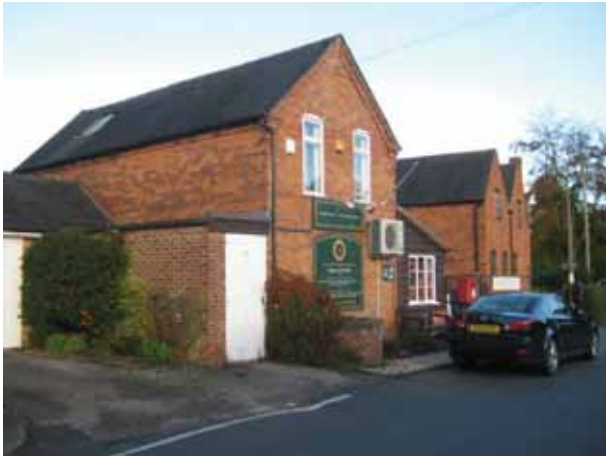
- The Cottage, Church Lane

When viewed with Church House this forms an important set piece on arrival to the village, terminating the view on turning west along Church Lane. It presents the orientation of the gable to the street, a character that is seen around the village.
